## **SAVVA Technical Tip 139 – Repairing aluminium thermostat housings**

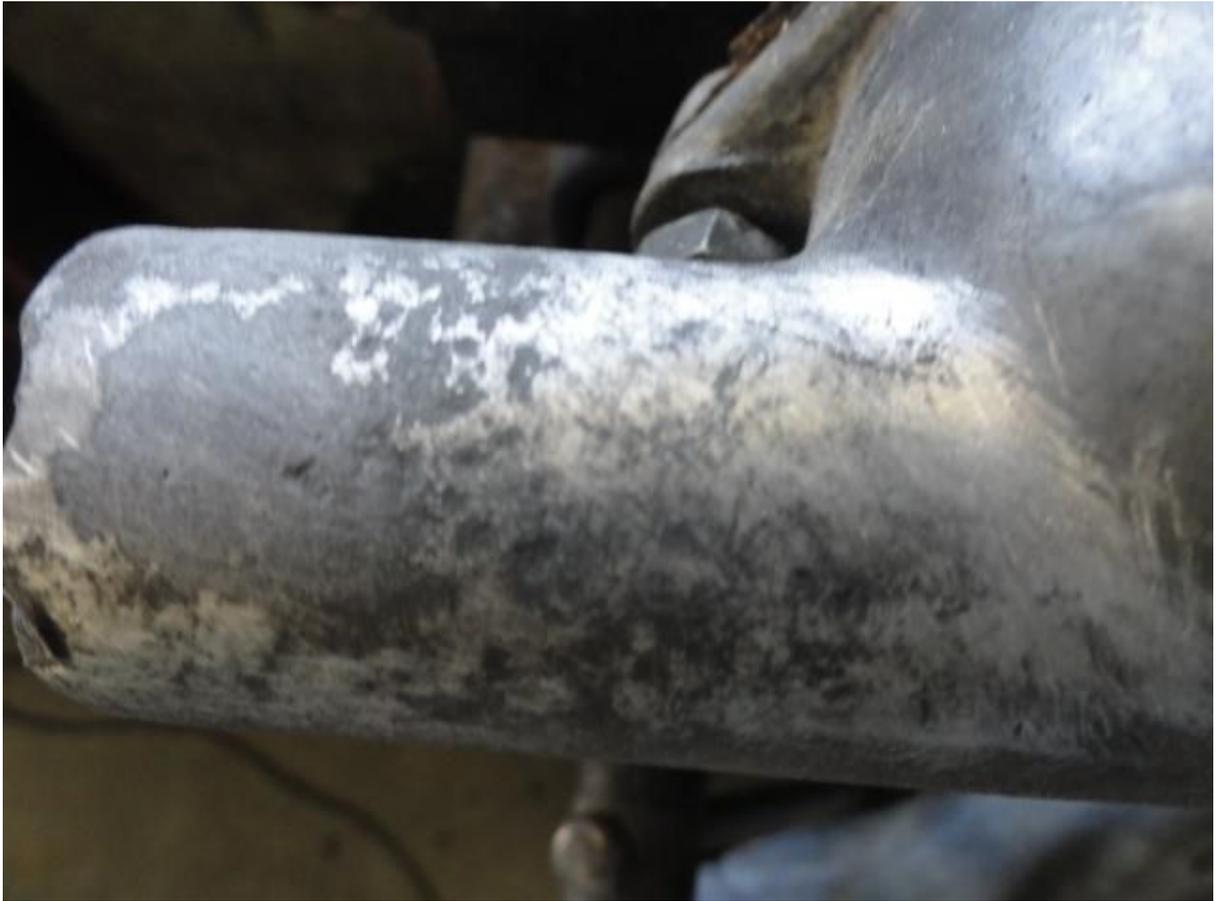
Following is a photo of the fitting. The dark area is the Q Bond filling.

Having little choice it was worth a try, so, I cleaned the corroded area with a wire brush and filled the affected area with this magic powder. One fills the affected area with the powder then drip what looks like super glues onto it. It sets rock hard and I was able to file it to shape within minutes.

I didn't expect it to be a permanent repair, however, if you can't get a replacement "van die rak af", you don't have much choice but to repair the old one even on a temporary basis. This temporary fix was over a year ago and recently I had to remove the top hose and the repair seems to be holding up very well. Incidentally, after the repair I filled the radiator with copious amounts of anti-corrosive additive (not antifreeze) to stop any further corrosion. This seems to have worked.
